**Flood Control Project Maintenance  
Levee Inspections**

**Fall 2010 Levee Maintenance Deficiency Summary Report**

**Reclamation District No. 0765 Glide**

**Levee Inspection Report By Mile - Fall 2010**

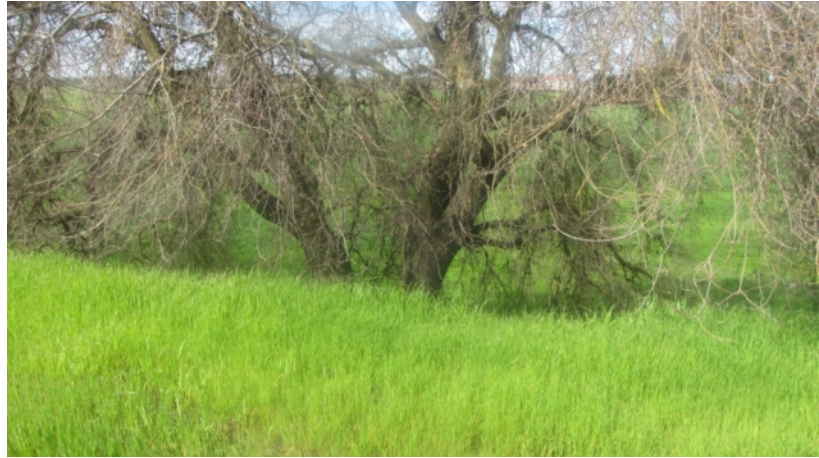
Levee Mile Report Line	4
Start Levee Mile	0.12
End Levee Mile	0.19
Location	Land Side
Category	Earthen Levee
Item	Trim / Thin Trees

Looking west at trees on landside toe.

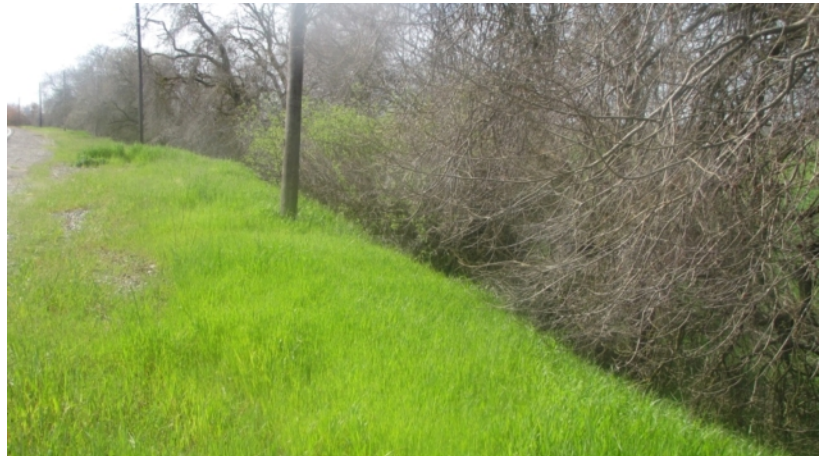
Levee Mile Report Line	4
Start Levee Mile	0.12
End Levee Mile	0.19
Location	Land Side
Category	Earthen Levee
Item	Trim / Thin Trees

Looking downstream (south) at trees on landside slope & toe.

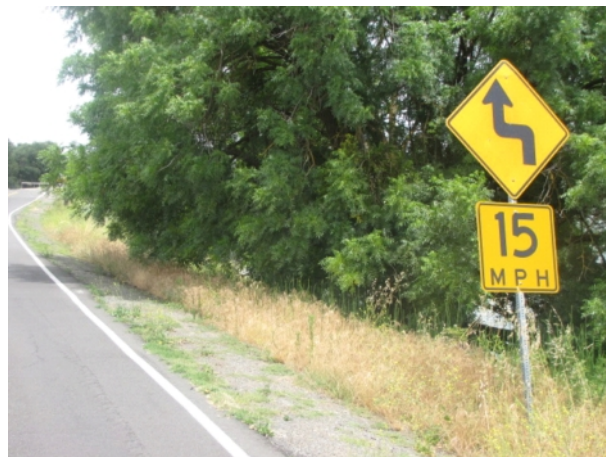
Levee Mile Report Line	7
Start Levee Mile	0.25
End Levee Mile	0.28
Location	Water Side
Category	Earthen Levee
Item	Trim / Thin Trees

Looking northeast at overgrown trees on waterside slope.

7	0.25	0.28	Earthen Levee	Trim / Thin Trees	WS	U	Thin trees to allow visibility of the ground and room to flood fight.	38.499405 ° -121.560445 °	38.499042 ° -121.560430 °	11 Y
8	0.32	0.32	Earthen Levee	Trim / Thin Trees	WS	C	Trim trees to at least five feet above ground level.	38.498473 ° -121.560372 °	38.498473 ° -121.560372 °	26
9	0.41	0.41	Earthen Levee	Trim / Thin Trees	LS	M	Trim trees to at least five feet above ground level.	38.497196 ° -121.560147 °	38.497196 ° -121.560147 °	21
10	0.41	0.47	Earthen Levee	Trim / Thin Trees	WS	C	Trim and thin trees to allow visibility of the ground and room to flood fight.	38.497129 ° -121.560093 °	38.496320 ° -121.559802 °	23
11	0.43	0.47	Earthen Levee	Trim / Thin Trees	LS	M	Trim and thin trees to allow visibility of the ground and room to flood fight.	38.496792 ° -121.560026 °	38.496321 ° -121.559842 °	32
12	0.48	0.50	Earthen Levee	Vegetation	LS	U	Remove the wild growth other than native grasses from the levee slopes.	38.496217 ° -121.559788 °	38.495855 ° -121.559586 °	33 Y

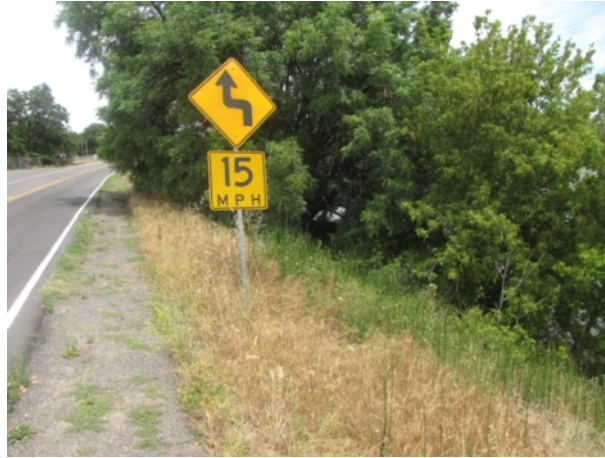
Levee Mile Report Line	7
Start Levee Mile	0.25
End Levee Mile	0.28
Location	Water Side
Category	Earthen Levee
Item	Trim / Thin Trees

Looking north at overgrown trees on waterside slope.

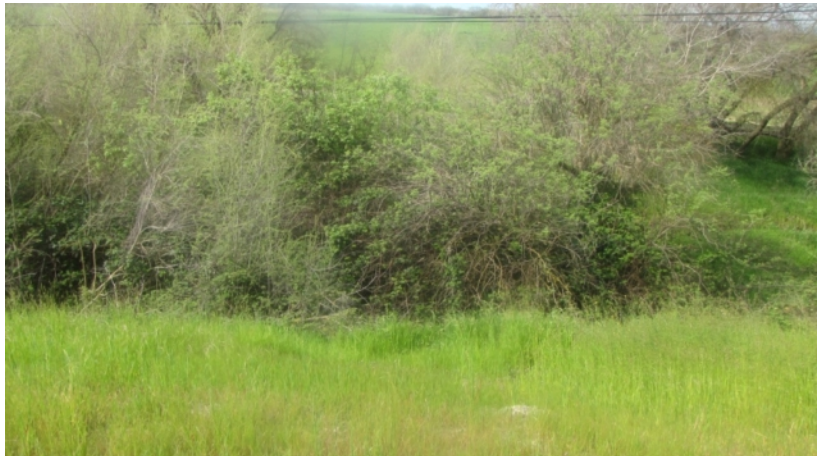
Levee Mile Report Line	12
Start Levee Mile	0.48
End Levee Mile	0.50
Location	Land Side
Category	Earthen Levee
Item	Vegetation

Looking northwest at trees on landside toe.

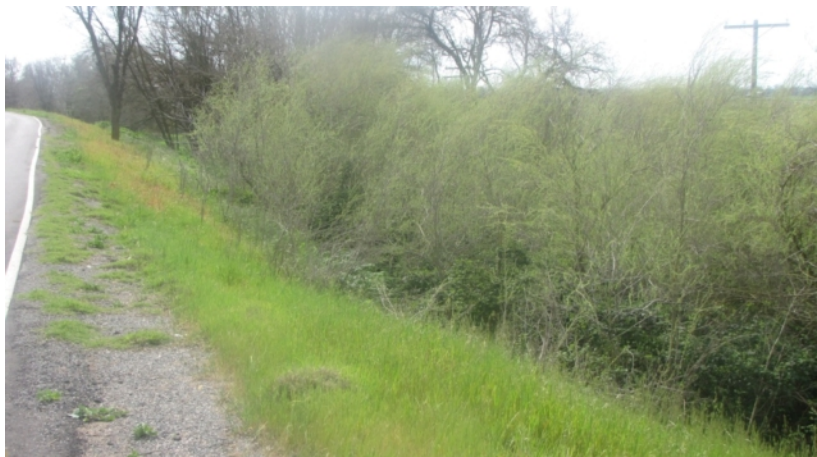
Levee Mile Report Line	12
Start Levee Mile	0.48
End Levee Mile	0.50
Location	Land Side
Category	Earthen Levee
Item	Vegetation

Looking downstream (south) at trees on landside slope & toe.

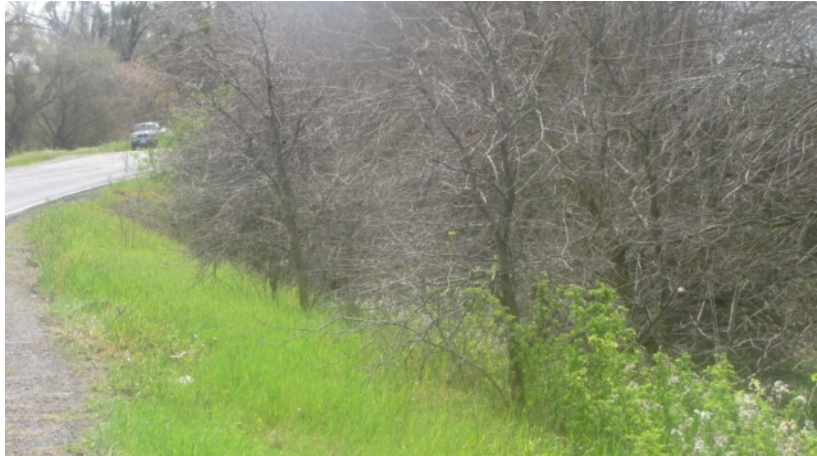
Levee Mile Report Line	22
Start Levee Mile	0.87
End Levee Mile	1.03
Location	Land Side
Category	Earthen Levee
Item	Trim / Thin Trees

Looking downstream (south) at trees on landside slope & toe.

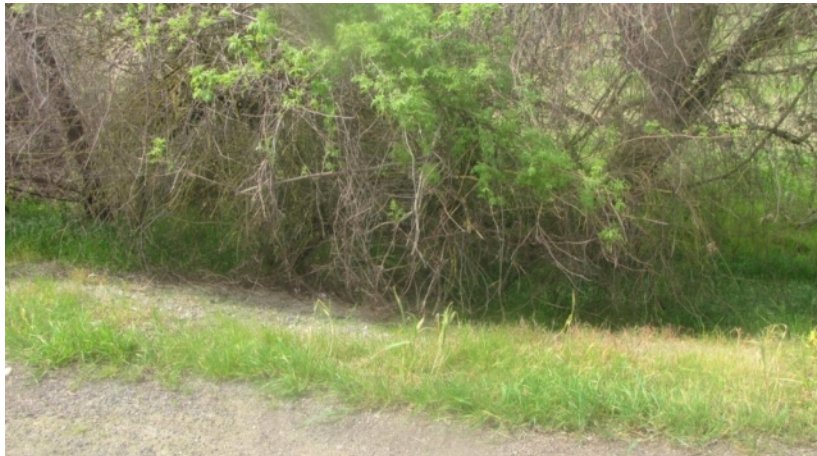
Levee Mile Report Line	22
Start Levee Mile	0.87
End Levee Mile	1.03
Location	Land Side
Category	Earthen Levee
Item	Trim / Thin Trees

Looking west at trees and vines on landside toe.

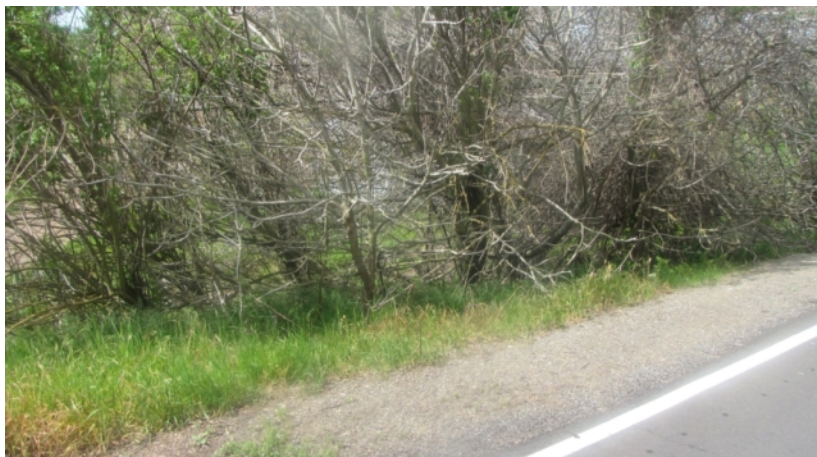
Levee Mile Report Line	22
Start Levee Mile	0.87
End Levee Mile	1.03
Location	Land Side
Category	Earthen Levee
Item	Trim / Thin Trees

Looking upstream (northwest) at trees on landside slope & toe.

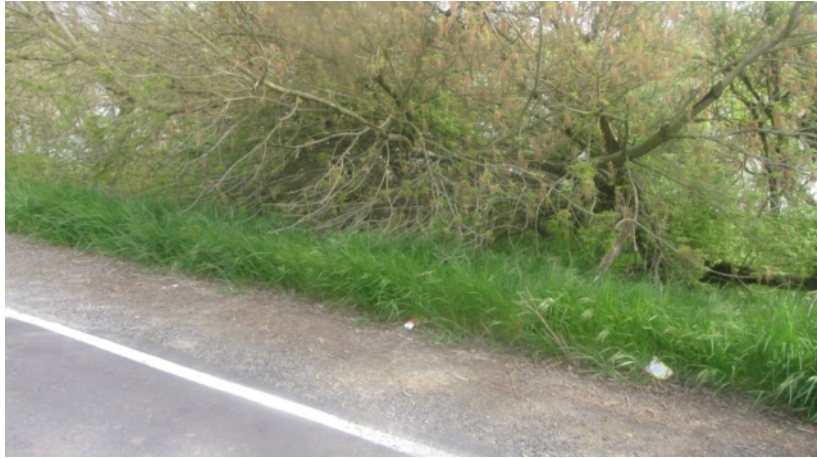
Levee Mile Report Line	24
Start Levee Mile	0.99
End Levee Mile	1.05
Location	Water Side
Category	Earthen Levee
Item	Trim / Thin Trees

Looking northeast at trees on waterside slope.

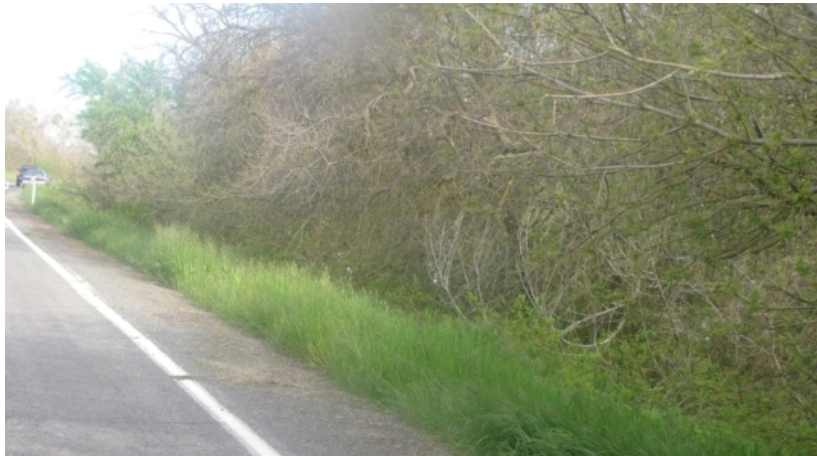
Levee Mile Report Line	24
Start Levee Mile	0.99
End Levee Mile	1.05
Location	Water Side
Category	Earthen Levee
Item	Trim / Thin Trees

Looking upstream (north) at trees on waterside slope.

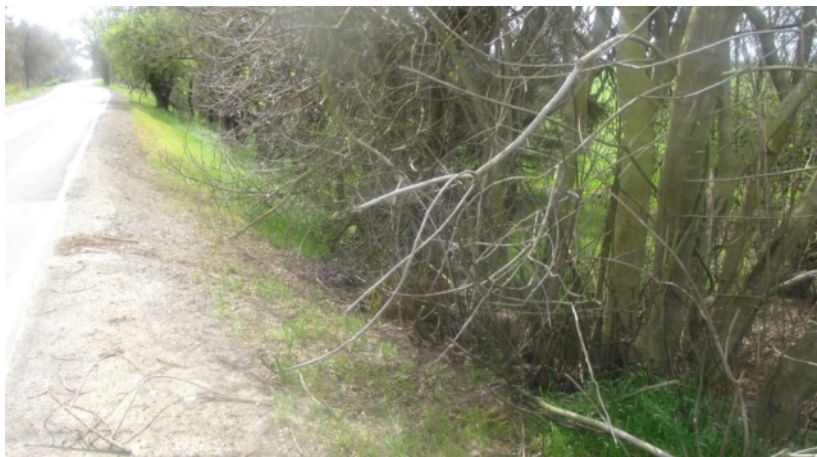
Levee Mile Report Line	25
Start Levee Mile	1.08
End Levee Mile	1.08
Location	Land Side
Category	Earthen Levee
Item	Trim / Thin Trees

Looking downstream (south) at trees on landside slope & toe.

25	1.08	1.08	Earthen Levee	Trim / Thin Trees	LS	U	Trim and thin trees to allow visibility of the ground and room to flood fight.	38.488503 ° -121.554757 °	38.488503 ° -121.554757 °	37 Y
26	1.10	1.16	Earthen Levee	Trim / Thin Trees	LS	M	Trim trees to at least five feet above ground level.	38.488279 ° -121.554615 °	38.487465 ° -121.554117 °	38
27	1.11	1.15	Earthen Levee	Vegetation	WS	M	Remove the wild growth other than native grasses from the levee slopes.	38.488108 ° -121.554488 °	38.487605 ° -121.554182 °	10
28	1.15	1.15	Earthen Levee	Vegetation	LS	M	Remove the wild growth other than native grasses from the levee slopes.	38.487653 ° -121.554248 °	38.487653 ° -121.554248 °	39 Y
29	1.16	1.16	Earthen Levee	Trim / Thin Trees	WS	M	Trim trees to at least five feet above ground level.	38.487473 ° -121.554080 °	38.487473 ° -121.554080 °	9
30	1.19	1.22	Earthen Levee	Encroachments	LS	CO	Buildings	38.487127 ° -121.553910 °	38.486702 ° -121.553652 °	43 Y

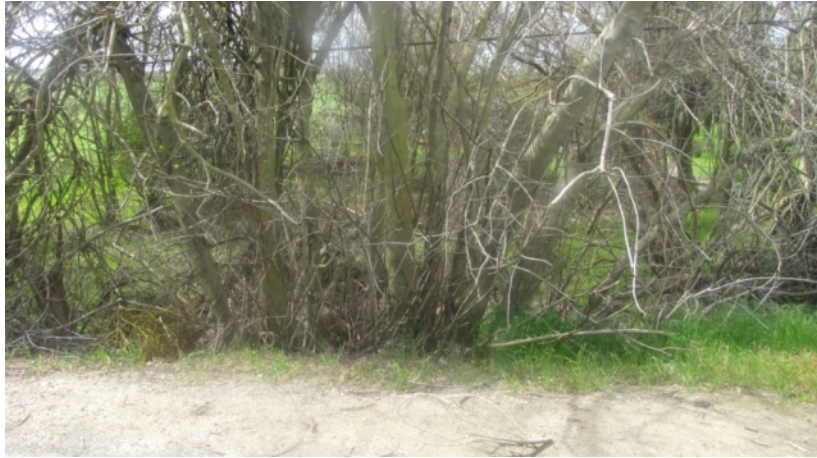
Levee Mile Report Line	25
Start Levee Mile	1.08
End Levee Mile	1.08
Location	Land Side
Category	Earthen Levee
Item	Trim / Thin Trees

Looking west at trees on landside slope & toe.

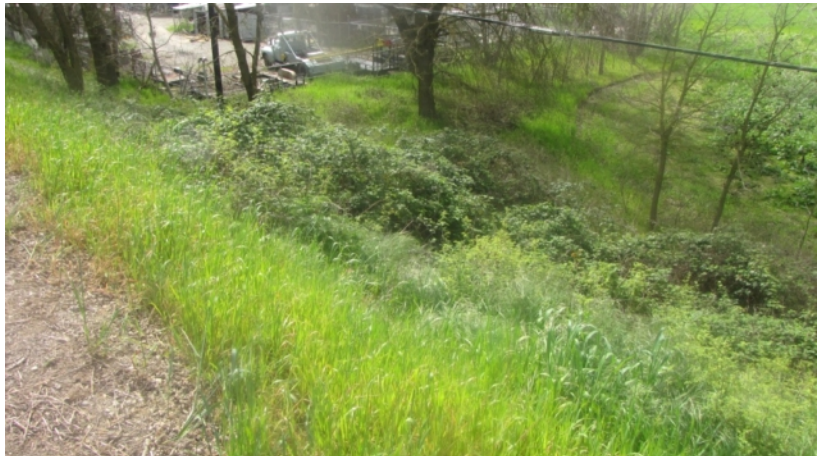
Levee Mile Report Line	28
Start Levee Mile	1.15
End Levee Mile	1.15
Location	Land Side
Category	Earthen Levee
Item	Vegetation

Looking downstream (southwest) at wild roses on landside slope & toe.

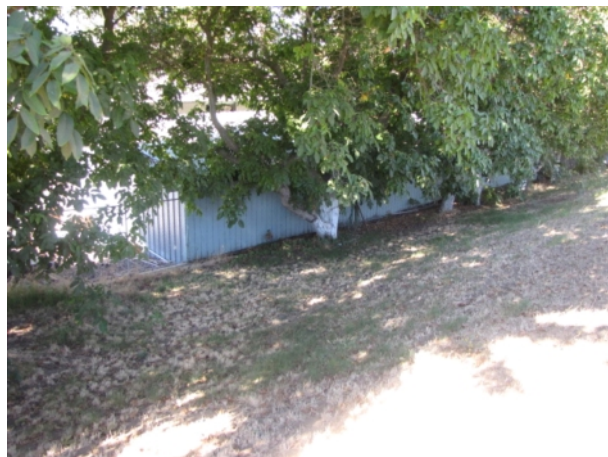
Levee Mile Report Line	30
Start Levee Mile	1.19
End Levee Mile	1.22
Location	Land Side
Category	Earthen Levee
Item	Encroachments

Looking northwest at buildings along landside toe.

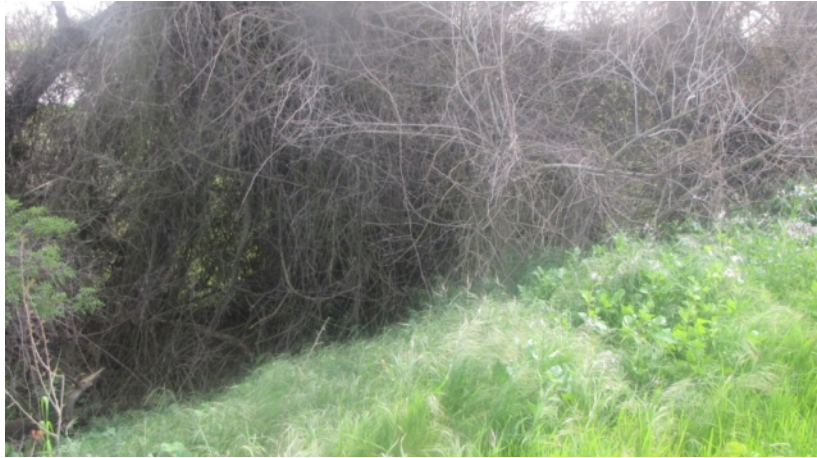
Levee Mile Report Line	32
Start Levee Mile	1.36
End Levee Mile	1.36
Location	Water Side
Category	Earthen Levee
Item	Trim / Thin Trees

Looking southeast (downstream) at trees on waterside slope.

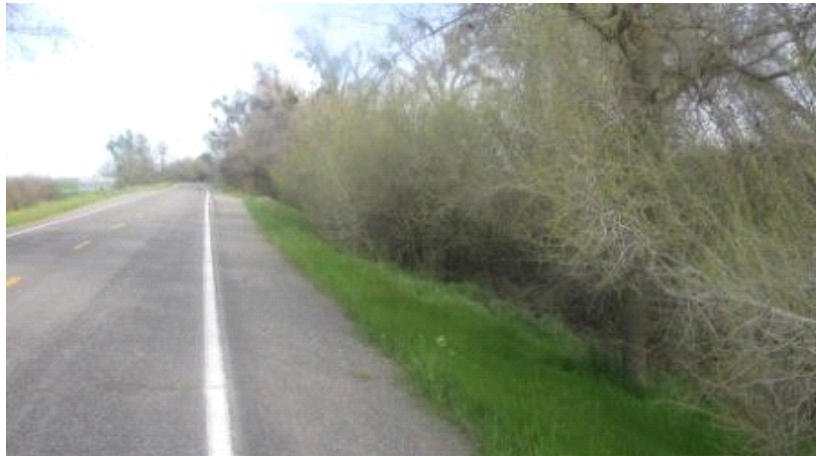
Levee Mile Report Line	35
Start Levee Mile	1.44
End Levee Mile	1.47
Location	Water Side
Category	Earthen Levee
Item	Trim / Thin Trees

Looking upstream (north) at trees on waterside slope.

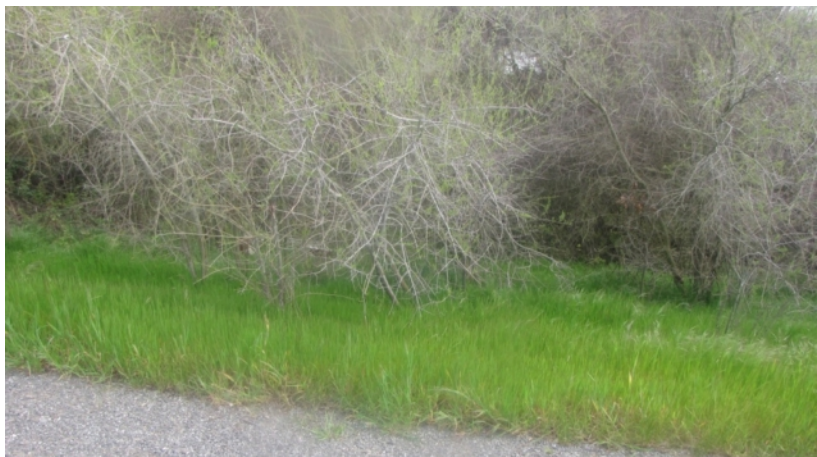
Levee Mile Report Line	35
Start Levee Mile	1.44
End Levee Mile	1.47
Location	Water Side
Category	Earthen Levee
Item	Trim / Thin Trees

Looking east at trees on waterside slope.

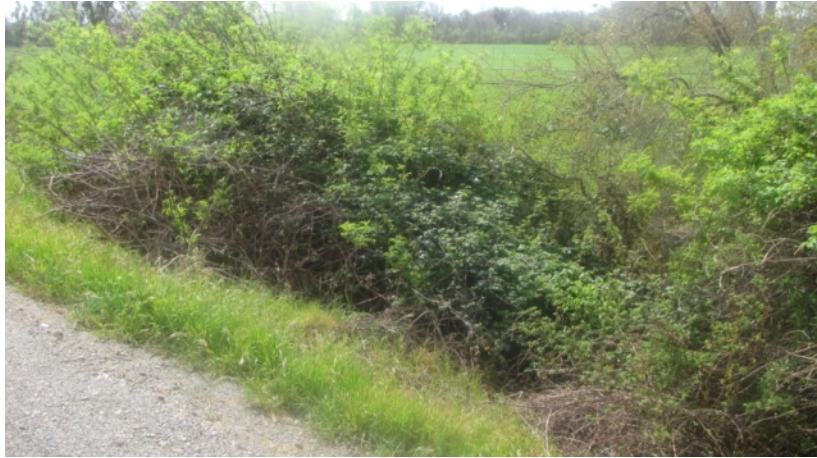
Levee Mile Report Line	39
Start Levee Mile	1.54
End Levee Mile	1.54
Location	Land Side
Category	Earthen Levee
Item	Vegetation

Looking downstream (southwest) at trees, vines & wildroses on landside slope & toe.

Waterway						Bank	Unit Miles	Inspection Start/End		Inspector
Unit No. 01 Sacramento River						Right	1.74	10/13/2010 10/13/2010		Richard Willoughby
LMR No.	Levee Mile		Category	Item	* Location	** Rating	Action/Comment	GPS Latitude/Longitude		Issue No.
	Start	End						Start	End	Photo
39	1.54	1.54	Earthen Levee	Vegetation	LS	U	Remove the wild growth other than native grasses from the levee slopes.	38.482590 ° -121.551020 °	38.482590 ° -121.551020 °	29 Y
40	1.60	1.67	Earthen Levee	Trim / Thin Trees	WS	M	Trim trees to at least five feet above ground level.	38.480913 ° -121.549677 °	38.480993 ° -121.549738 °	2 Y
41	1.60	1.60	Earthen Levee	Vegetation	WS	M	Remove the wild growth other than native grasses from the levee slopes.	38.481841 ° -121.550438 °	38.482028 ° -121.550512 °	31
42	1.69	1.69	Earthen Levee	Encroachments	WS	M	Garbage	38.480770 ° -121.549514 °	38.480895 ° -121.549556 °	30 Y
43	1.70	1.73	Earthen Levee	Trim / Thin Trees	WS	M	Trim trees to at least five feet above ground level.	38.480602 ° -121.549523 °	38.480257 ° -121.549458 °	1 Y

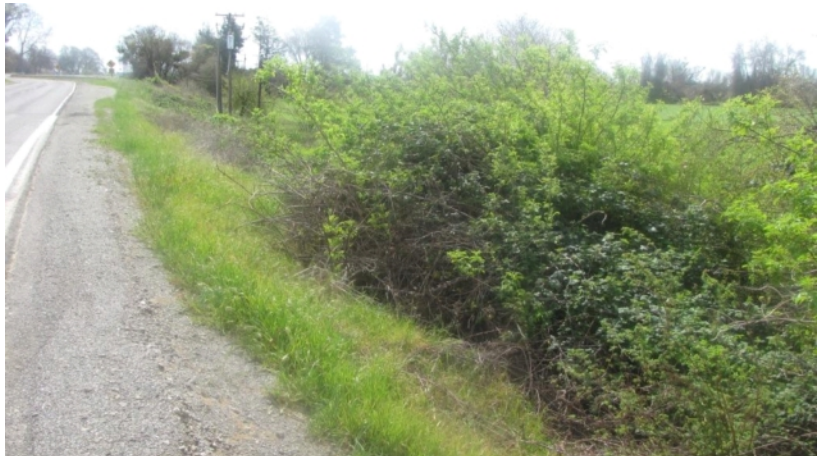
Levee Mile Report Line	39
Start Levee Mile	1.54
End Levee Mile	1.54
Location	Land Side
Category	Earthen Levee
Item	Vegetation

Looking downstream (south) at trees, vines & wildroses on landside slope & toe.

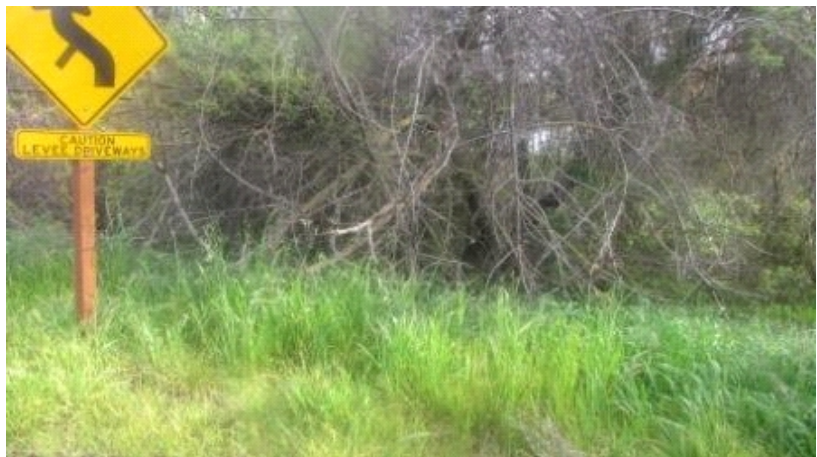
Levee Mile Report Line	40
Start Levee Mile	1.60
End Levee Mile	1.67
Location	Water Side
Category	Earthen Levee
Item	Trim / Thin Trees

Looking east at trees on waterside slope.

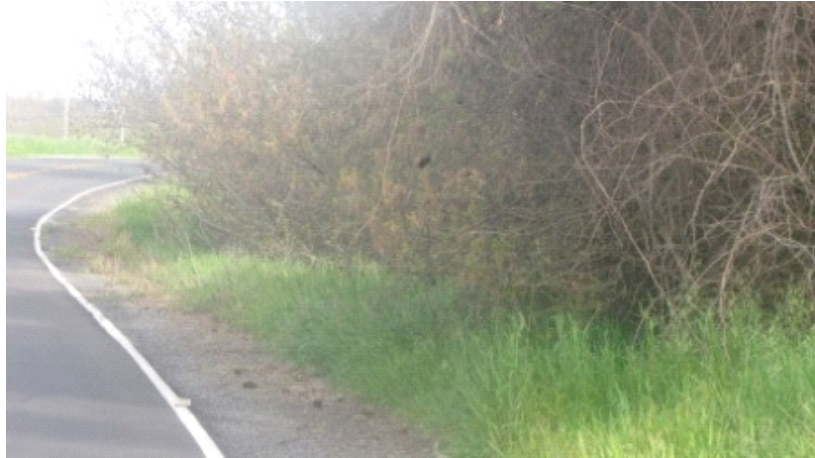
Levee Mile Report Line	40
Start Levee Mile	1.60
End Levee Mile	1.67
Location	Water Side
Category	Earthen Levee
Item	Trim / Thin Trees

Looking upstream (north) at trees on waterside slope.

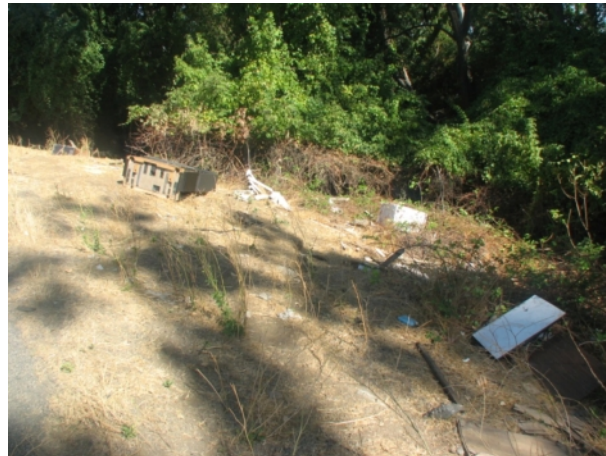
Levee Mile Report Line	42
Start Levee Mile	1.69
End Levee Mile	1.69
Location	Water Side
Category	Earthen Levee
Item	Encroachments

Looking upstream at garbage on waterside slope.

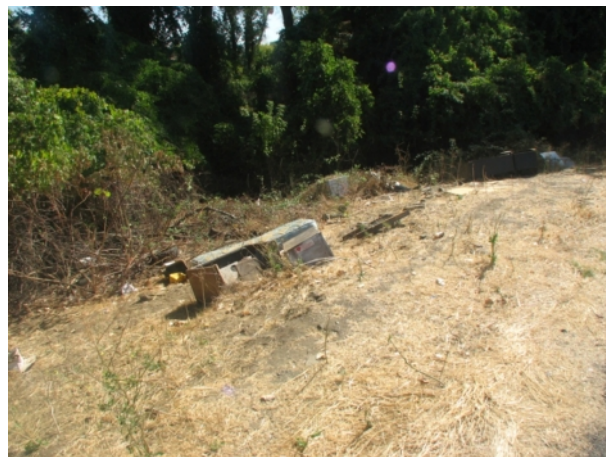
Levee Mile Report Line	42
Start Levee Mile	1.69
End Levee Mile	1.69
Location	Water Side
Category	Earthen Levee
Item	Encroachments

Looking downstream at garbage on waterside slope.

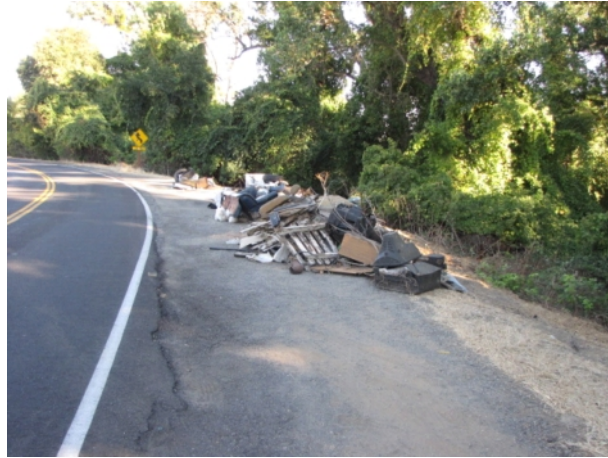
Levee Mile Report Line	42
Start Levee Mile	1.69
End Levee Mile	1.69
Location	Water Side
Category	Earthen Levee
Item	Encroachments

District manager has stack garbage on shoulder to be haul away. (Looking north)

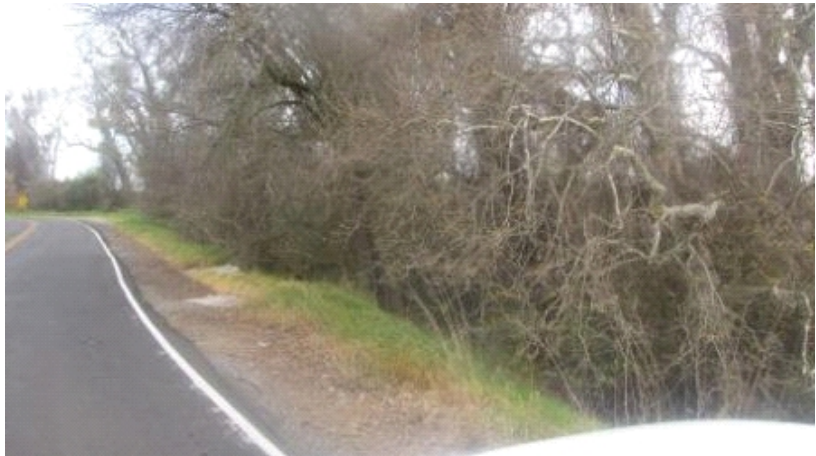
Levee Mile Report Line	43
Start Levee Mile	1.70
End Levee Mile	1.73
Location	Water Side
Category	Earthen Levee
Item	Trim / Thin Trees

Looking upstream (north) at trees on waterside slope.

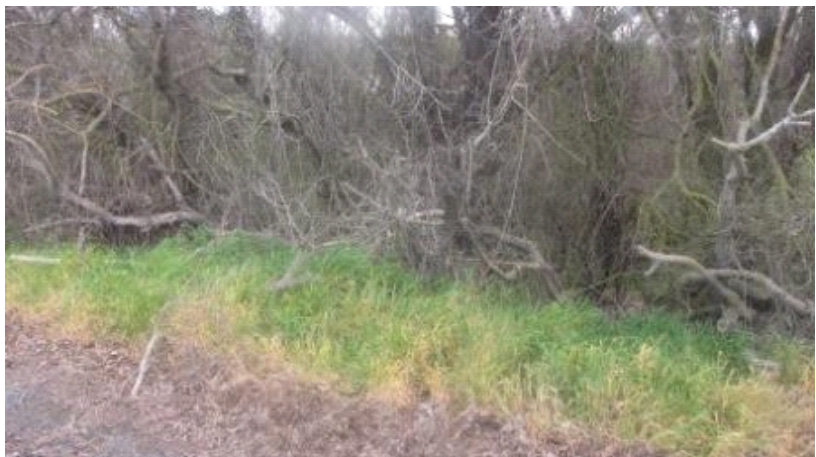
Levee Mile Report Line	43
Start Levee Mile	1.70
End Levee Mile	1.73
Location	Water Side
Category	Earthen Levee
Item	Trim / Thin Trees

Looking east at trees on waterside slope.
